CONSTRUCTION FOUNDATION REPORT

MISSOURI RIVER
GARRISON DAM - LAKE SAKAKAWEA

VOLUME I
TEXT AND PHOTOS

NOVEMBER 1983

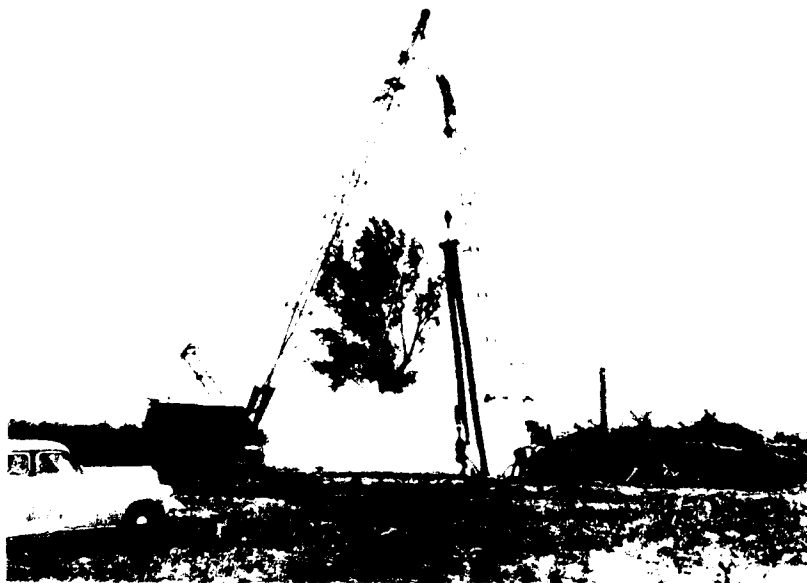
Extraction of the piling for observation of the physical condition of each sheet began 25 May 1948 and was completed on 15 June 1948. All of the piling was found to be in good condition except Pile No. 6 which had 4.6 feet of its bottom distorted into a wavy shape with the lock on one side of the pile broken for about 4.6 feet. See Photos 5 and 6.

PHOTO NO. 5 View of test pile driving operations

PHOTO NO. 6 View of test pile extraction operation
